NPDES Inspection Report

Waste Management Disposal Services of Oregon, Inc. (Alaska Street Reload)

Seattle, Washington

March 7, 2012

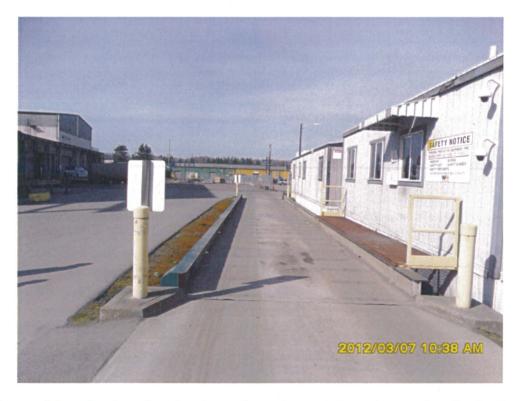
Photo #2: Westerly view showing the scale used to weigh trucks entering the facility.

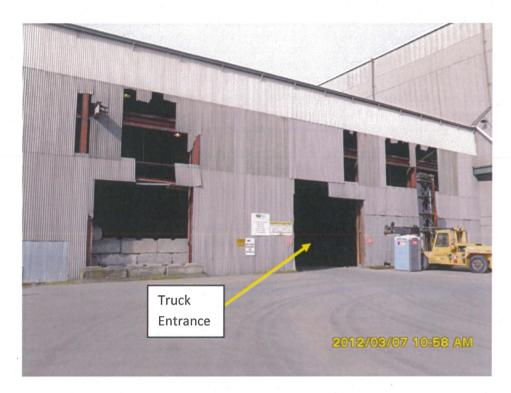
Photo #3: View of the building which houses the contaminated materials brought to the facility. Note the truck entrance to the building.

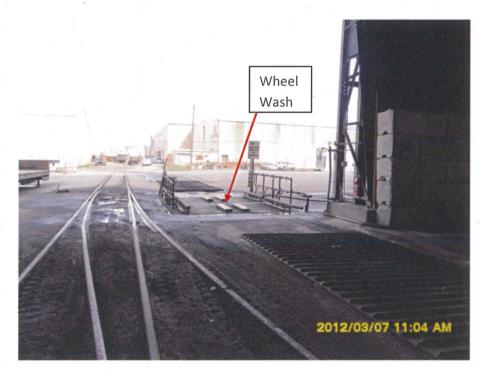
Photo #6: Northerly view from within the contaminated material storage building. Note the wheel wash area in the center of the photograph.

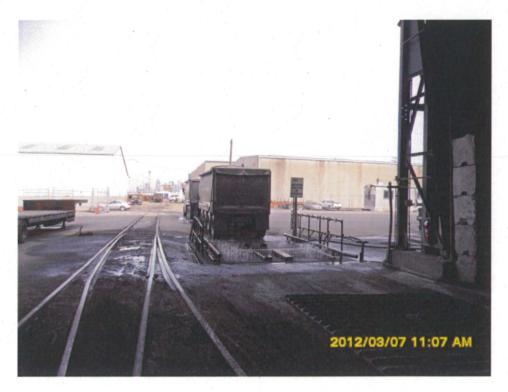
Photo #7: View of the wheel wash showing the end of a wash cycle.

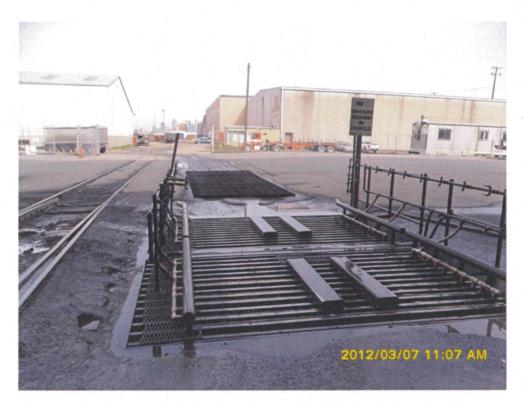
At the time of the inspection, I inspected the area in the vicinity of the wheel wash. As indicated above, I saw a trail of wet pavement leading from the wheel wash area to the northern property boundary along Alaska Street. Note that this pavement was wet even though the weather

condition on the day of the inspection was clear and dry. Also note that the wet pavement ended only several feet from storm drains located along Alaska Street.

Photo #8: Close-up of the truck wheel wash. Note the wet pavement beyond the wheel wash area.

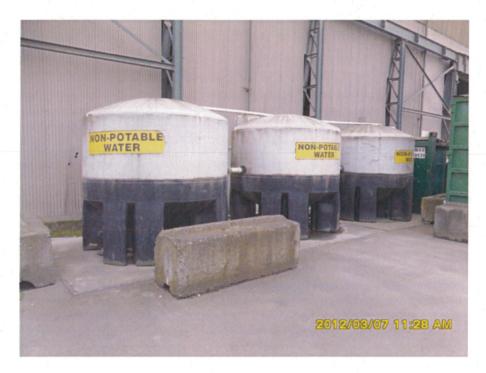
Photo #9: View of the truck wheel wash water treatment system.

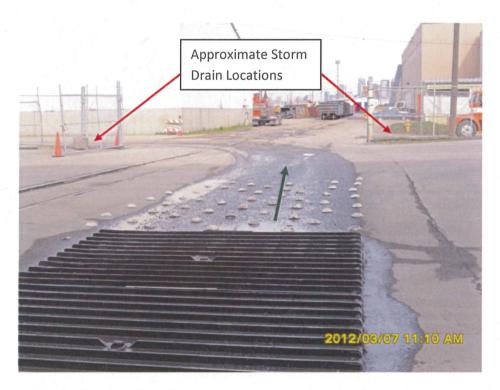
In addition to the overflow discharge mentioned above, it appears that the potential also exists for wheel wash wastewater to enter nearby storm drains via the track out of wheel wash water by trucks leaving the facility. The potential for discharge is suggested by my observations at the time of the inspection. Although the weather was clear and dry at the time of the inspection, I saw a trail of wet pavement leading north from the wheel wash to the property boundary along Alaska Street. See photograph #s 8 and 10 to 12 of attachment C for details of the material track out at the time of the inspection. Note that material from the wheel wash is being tracked out to an area in the vicinity of two storm drains along Alaska Street (located an estimated 80 feet away from the wheel wash). Although I did not see the wet pavement lead all the way to the storm drains at the time of the inspection, the area of the tracked out material does slope towards the storm drains creating the potential for discharge.

The concern is that material being tracked out from this facility may be entering nearby storm drains during rain events. I raised this concern to Mr. Borghese at the time of the inspection and he indicated that the company is already looking at modifying the truck traffic flow path to deal with this concern.

Photo #10: Northerly view showing wastewater from the wheel wash being tracked out the north entrance to the facility. Note the stormwater drains situated just outside the fence on the left (west) and right (east) side of the entrance to the facility. The photographer is standing in the vicinity of the wheel wash.

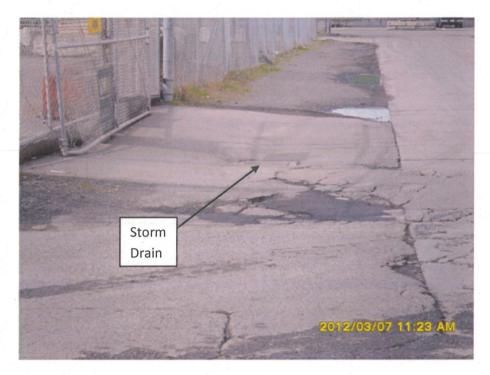
Photo #11: Westerly view showing the storm drain just outside of and west of the facility entrance along Alaska Street. The facility is situated to the left of this photograph.

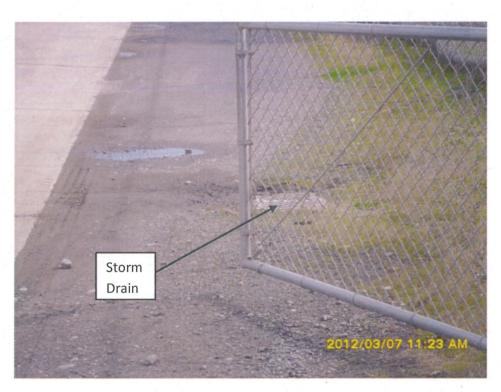
Photo #12: Easterly view showing the storm drain just outside of and east of the facility entrance along Alaska Street. The facility is situated to the right of this photograph.

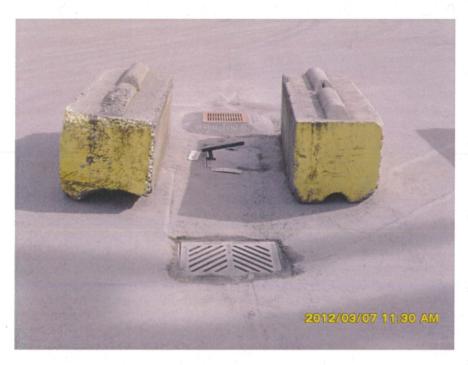
However, according to John Borghese, outfall A is no longer used as a discharge point. All collected stormwater is now routed through outfall B.

Photo #13: View of sample point A (outfall A). This drain was used in the past to route stormwater from the facility to the stormwater system. According to Mr. John Borghese, water entering this drain is now only routed to either the truck wheel wash system or it is routed to sample point B (outfall B).

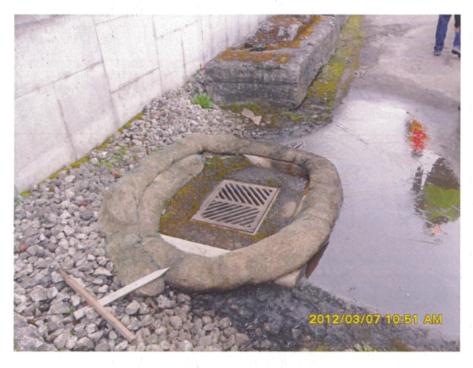
Photo #14: View of sample point B (outfall B). This is the only stormwater discharge point remaining at the facility.

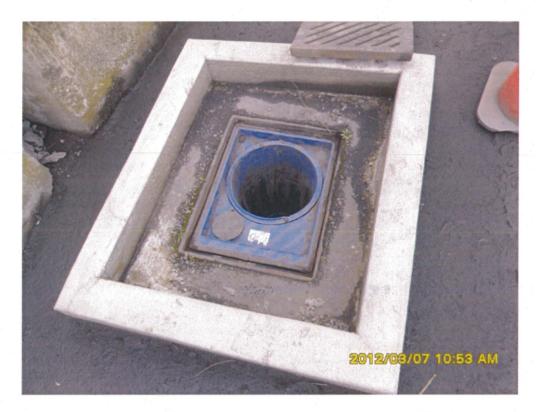
At the time of the inspection, Mr. Borghese indicated that the treatment selected and installed at this facility is catch basin filter inserts. These filter inserts were required to be installed by September 30, 2011. Note that sample results for samples collected after the treatment system installation showed reduced zinc levels, however, the benchmark zinc value was still exceeded.

Photo #15: View of the one of the catch basin inserts used at this facility.

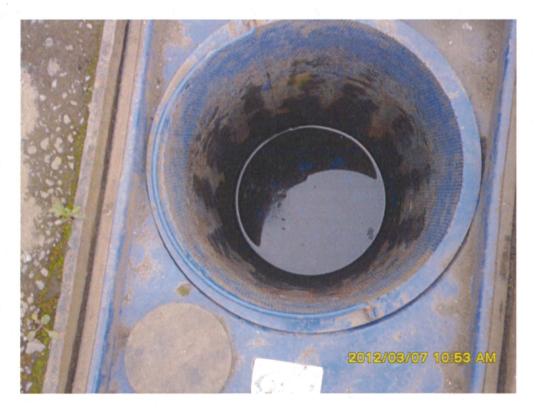
Photo #16: Another view of one of the catch basin inserts at this facility.

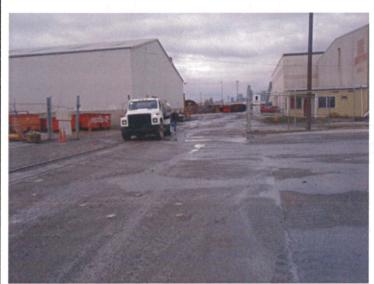
#1. DESCRIPTION: Wastewater from the wheel wash is migrating out the entrance gate. The wheel wash system is just to rear of photographer.

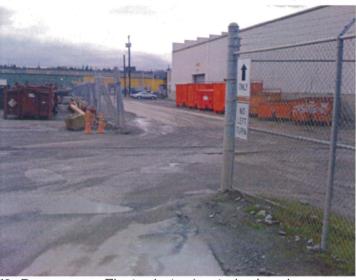
#2. <u>DESCRIPTION:</u> The trucks track out wheel wash wastewater and dirt onto Alaska Street. The storm drain catch basin seen in Photo # 4 is just below and to right of "No Left Turn" sign.

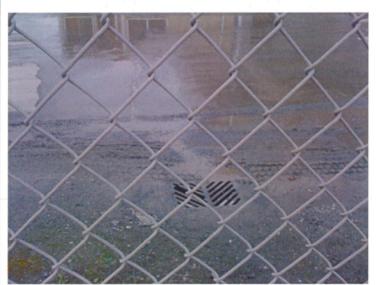
#3. <u>DESCRIPTION:</u> This storm drain catch basin is located just outside of entrance gate to the east (and is referred to as the east storm drain). Wheel wash wastewater can be seen flowing into it.

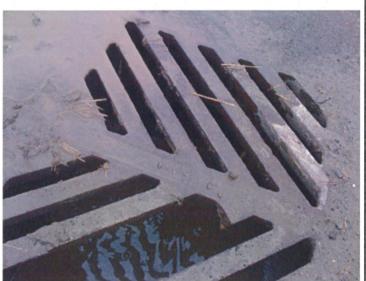
#4. DESCRIPTION: This storm drain catch basin is full of petroleum contaminated muddy water.

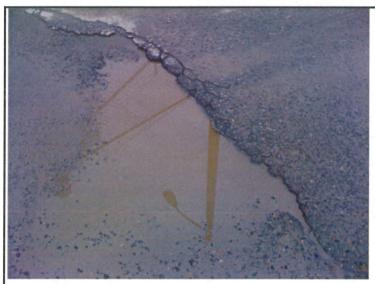
#5. <u>DESCRIPTION:</u> A petroleum sheen can clearly be seen on this puddle of water is just outside main gate.

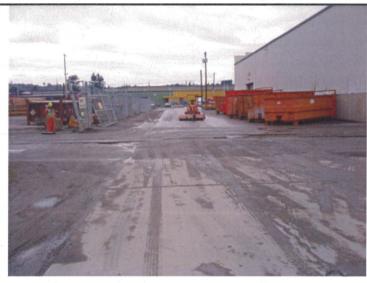
#6. <u>DESCRIPTION:</u> Excessive trackout from the Alaska Street Reload facility onto Alaska Street can be seen.

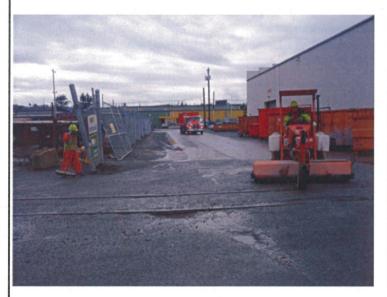
#7. DESCRIPTION: The facility is aware that the wheel wash system is not adequate to protect water quality and comply with permit requirements.

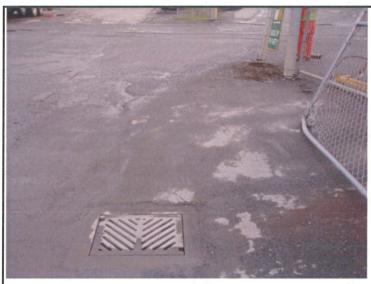
#9. DESCRIPTION: The trucks leaving the facility track contaminated dirt and wheel wash wastewater onto Alaska Street. This catch basin is connected to a storm drainage system that flows to the Duwamish River (also seen in Photo # 26).

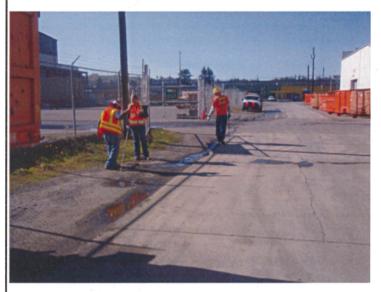
#11. <u>DESCRIPTION:</u> The water seen flowing out of the facility gate is wheel wash wastewater. The discharge of wastewater to surface waters or storm drains is not permitted, as noted in warning letters to Waste Management.

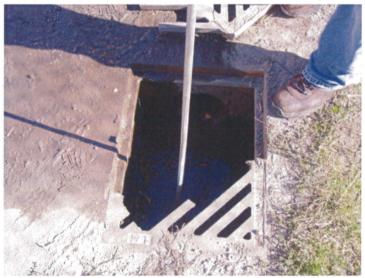
#12. <u>DESCRIPTION:</u> This storm drain catch basin is still receiving wheel wash wastewater from the Alaska Street Reload Facility. This water is contaminated with petroleum and sediment.

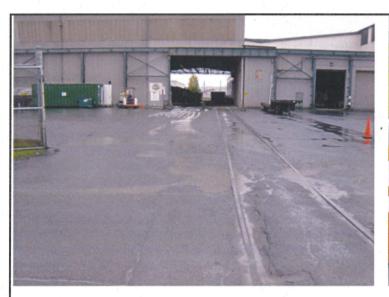
#13. DESCRIPTION: In response to a complaint about trackout onto Alaska Street, Ecology again found the wheel wash system at this facility to be inadequate.

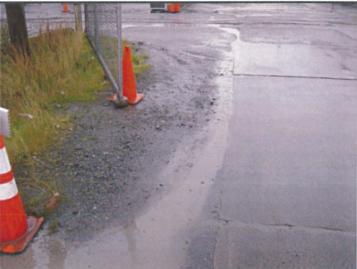
#14. DESCRIPTION: The wheel wash wastewater flows out the gate and directly into the storm drain catch basin. The storm drain is just under the white striped orange cone. (see also Photo # 15)

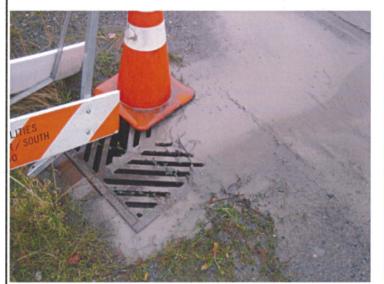
#15. <u>DESCRIPTION:</u> This catch basin is referred to as the east storm drain and is receiving muddy petroleum contaminated water. This water smelled like petroleum and had a visible sheen on it.

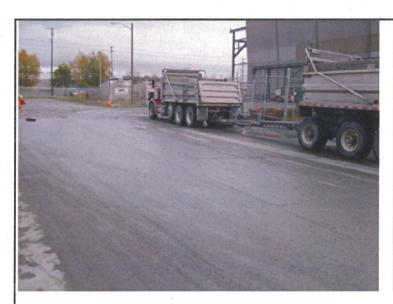
#17. <u>DESCRIPTION:</u> The trackout from this facility is again found to be excessive. The muddy road contributes to stormwater pollution of the storm drains on Alaska Street.

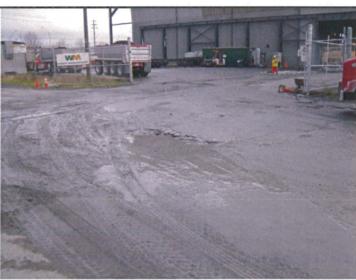
#18. DESCRIPTION: The facility is aware of the excessive trackout and inadequate wheel wash system but continues with full operation.

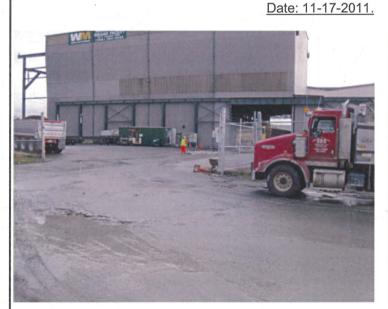
#19. DESCRIPTION: The facility has staff trying to sweep the wheel wash wastewater back into the overflowing wheel wash system. The catch basin seen in Photo # 26 is just beside right front wheel of red truck.

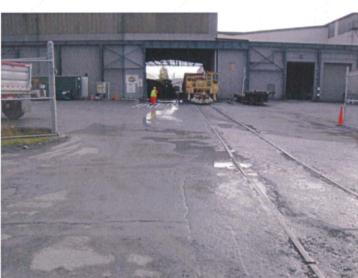
#20. <u>Description:</u> The wheel wash wastewater can clearly be seen flowing out the entrance gate. Most of this flow ends up in the east storm drain.

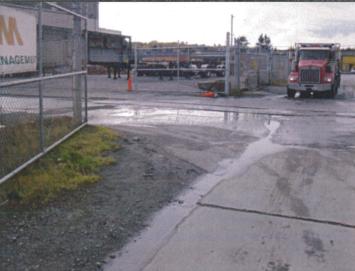
#22. DESCRIPTION: The water in this photo is wheel wash wastewater and is flowing into the east storm drain.

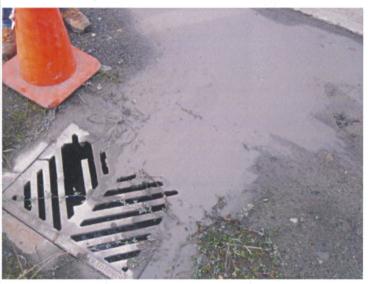
#23. <u>DESCRIPTION:</u> This east storm drain is receiving petroleum contaminated wastewater. A petroleum sheen can be seen on this muddy water and the water smelled of petroleum. Samples were collected at this location.

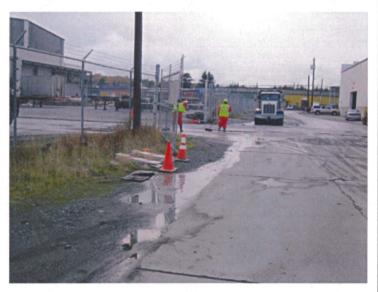
#24. <u>Description:</u> Petroleum contaminated wastewater has been flowing into storm drains tributary to the Duwamish River from this facility for many days over the past 4 years. The facility has been aware of the inadequacy of the wheel wash system and but failed to implement improvements to comply with permit and water quality requirements.

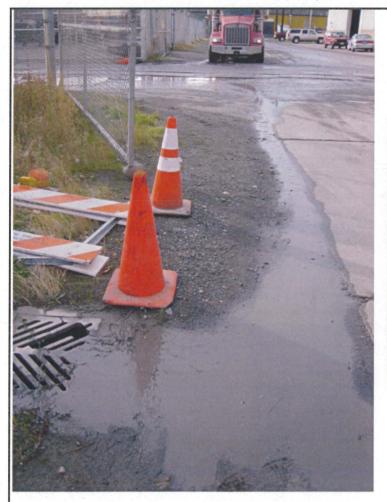
#25. <u>Description:</u> The overflowing wheel wash was resulting in the discharge of wastewater to the east and west storm drains which are tributary to the Duwamish River.

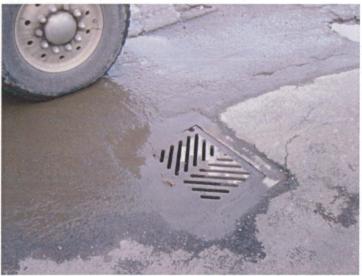
#26. DESCRIPTION: This storm drain catch basin is referred to as the west storm drain and is receiving trackout run-off and wheel wash wastewater.
